Miramichi River Environmental Assessment Committee

Napan River Sub- Watershed Monitoring Project

1997-98

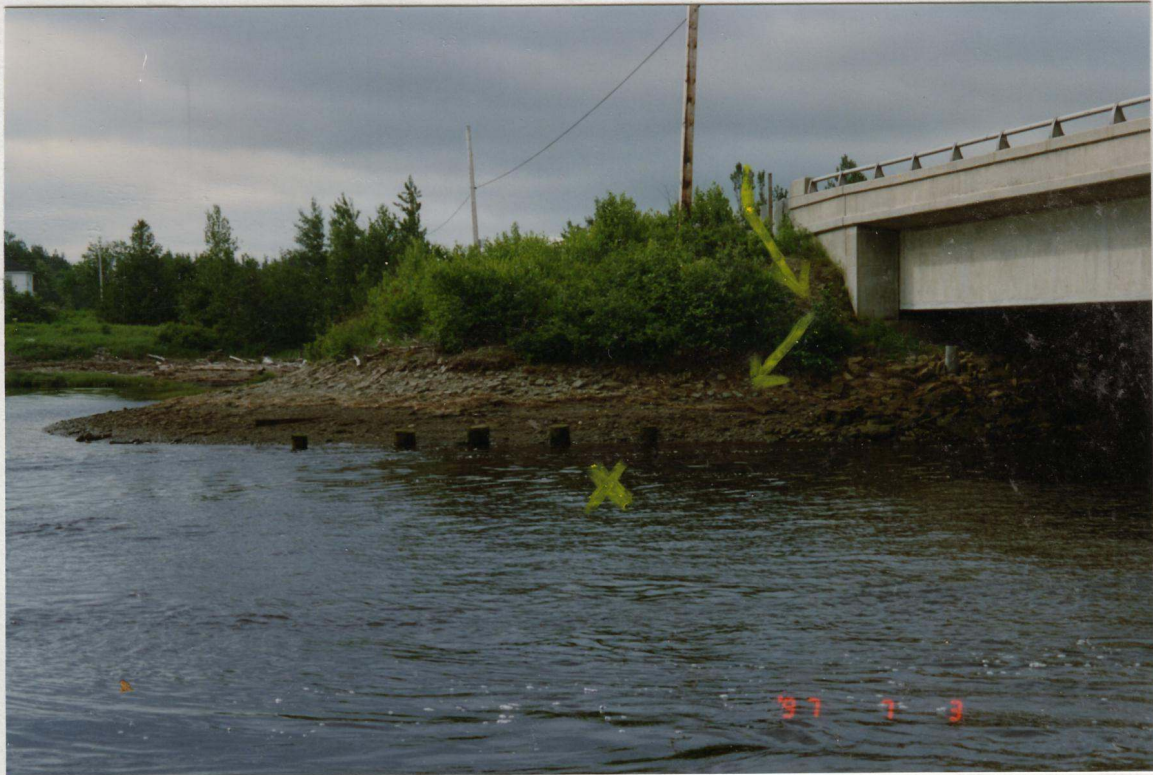
SITE #1

Site #1- Sample is taken from the South side of the river, down river from the bridge from between the first and second cut off pillions. This bridge is the lowest sample site on the Napan River, known as the Sweezey Bridge.

"SWEZEY BRIDGE"

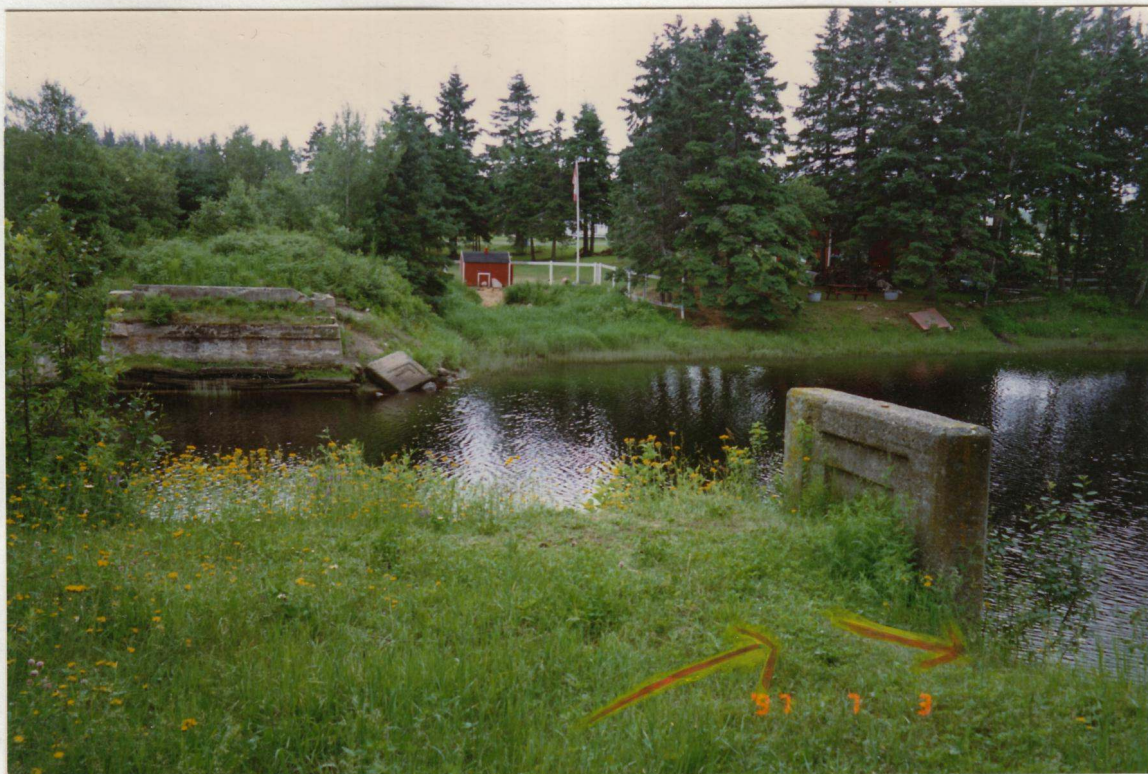
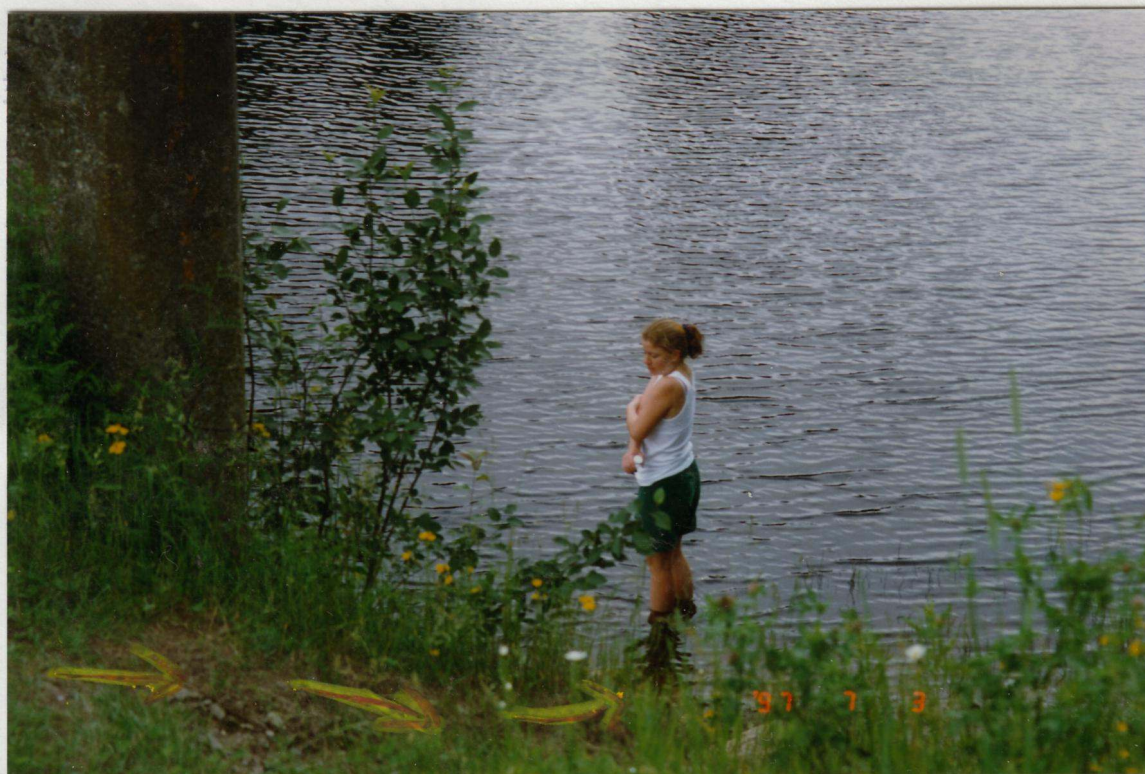
SITE #2

Sites #2- Sample is taken from the North side of the river at an old bridge embankment “Old White Bridge”. Access via long lane to get to river.

Two of seven sites contained elevated levels of bacteria, these sites were at the Old White Bridge and Johnson Bridge.

"OLD WHITE BRIDGE"

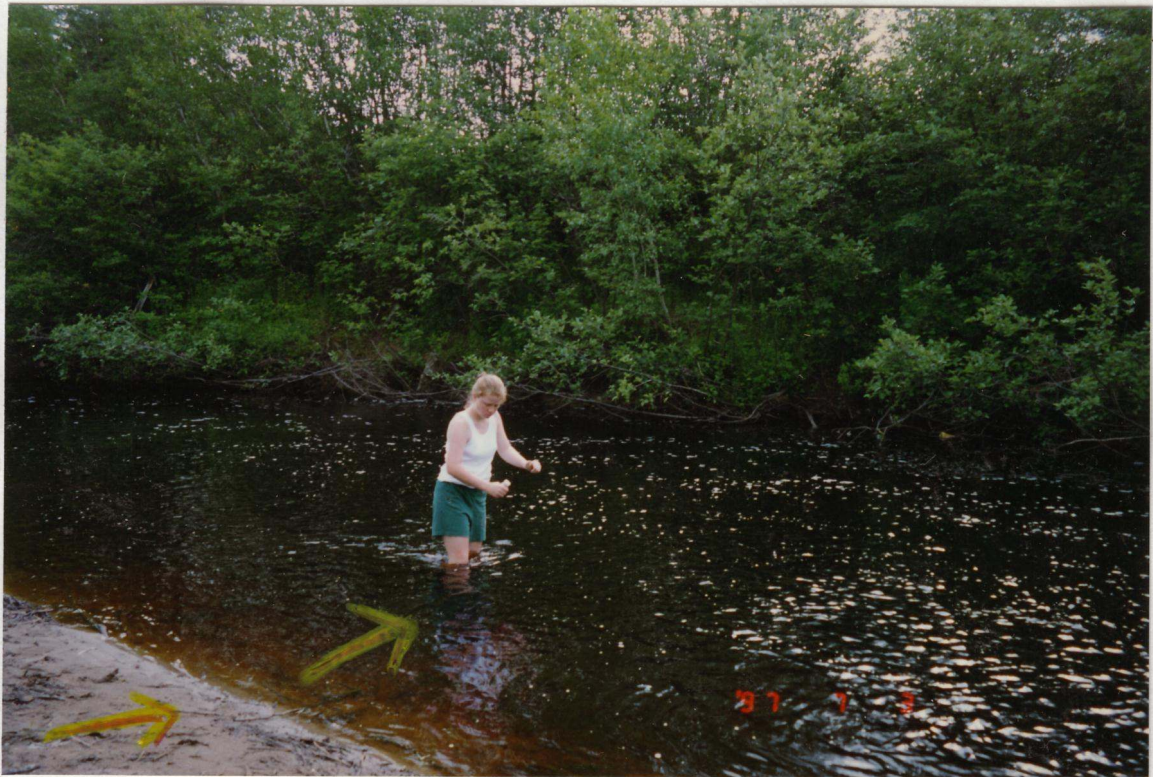
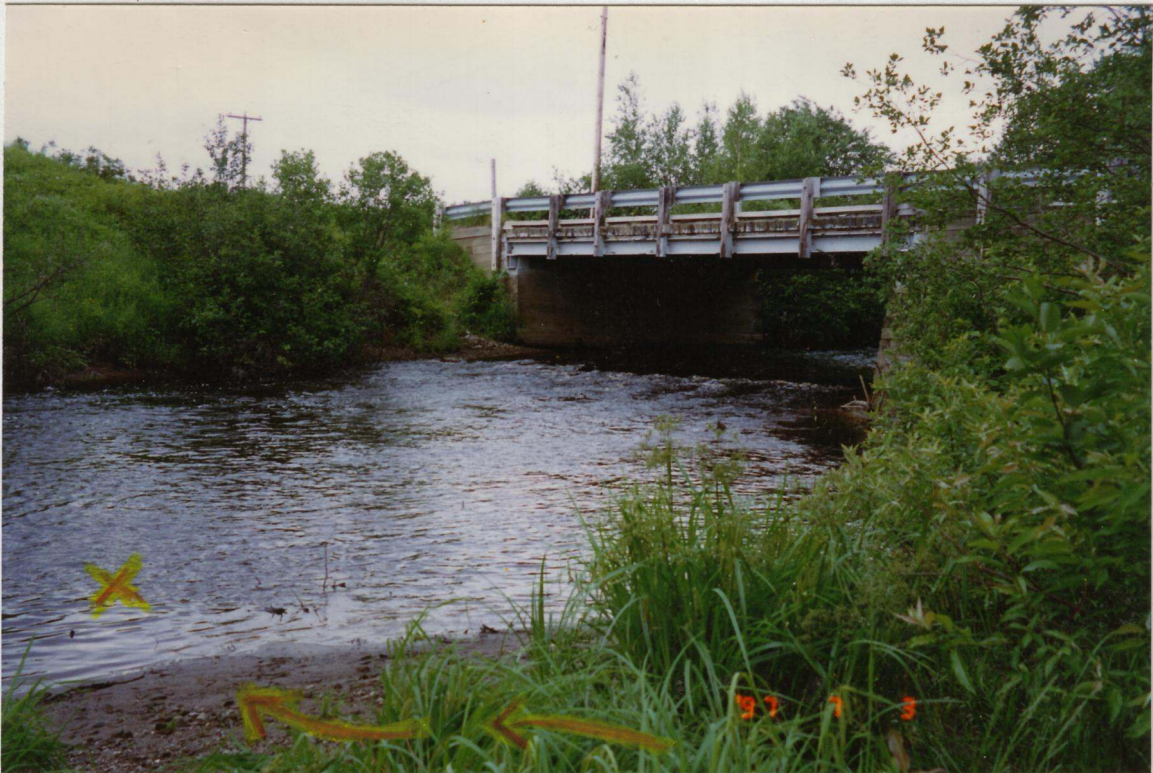
SITE[#] 3

Site #3- Sample is taken from the North side of the river on the down side of “Johnson’s Bridge”. It is the bridge on the road beside the Napan Elementary School that runs from North Napan Road to South Napan Road.

"JOHNSON'S BRIDGE"

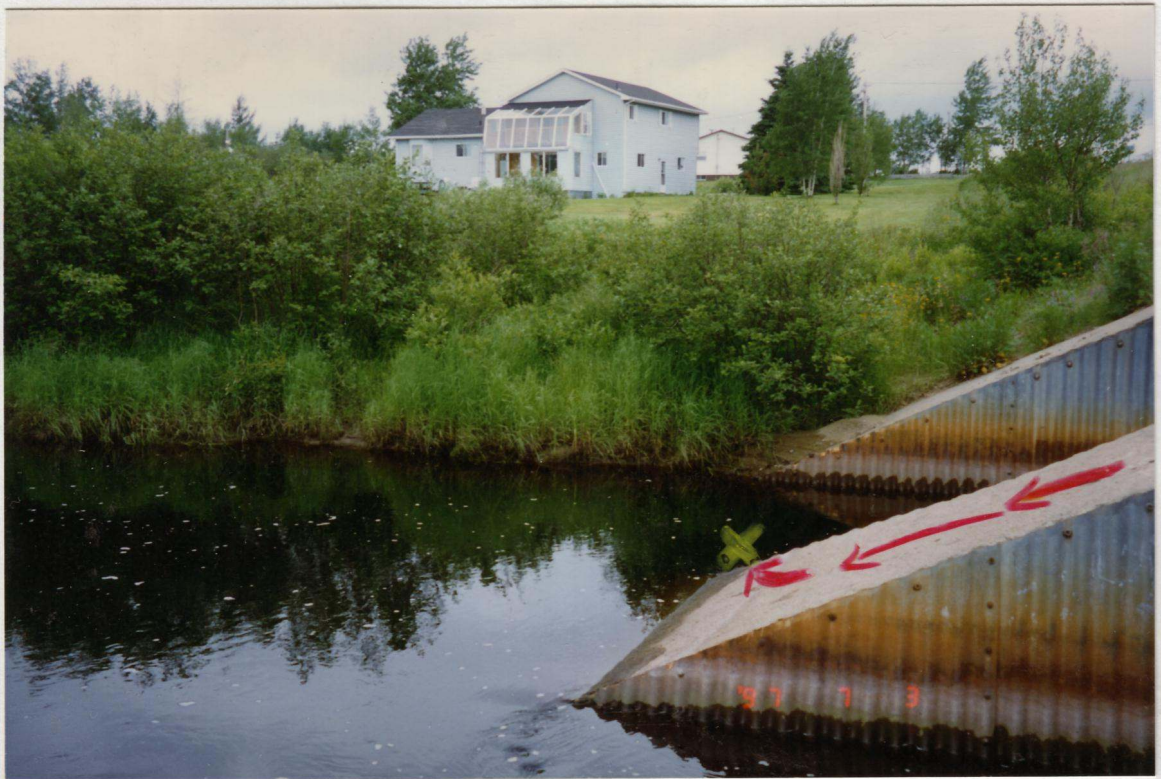
SITE #4

Site #4- Sample is taken at bridge on Highway 11 from concrete ramp separating the two culverts. Sample from the right hand or north tunnel if you are facing west. The sample is from the upriver side of the bridge.

"HIGHWAY 11 BRIDGE"

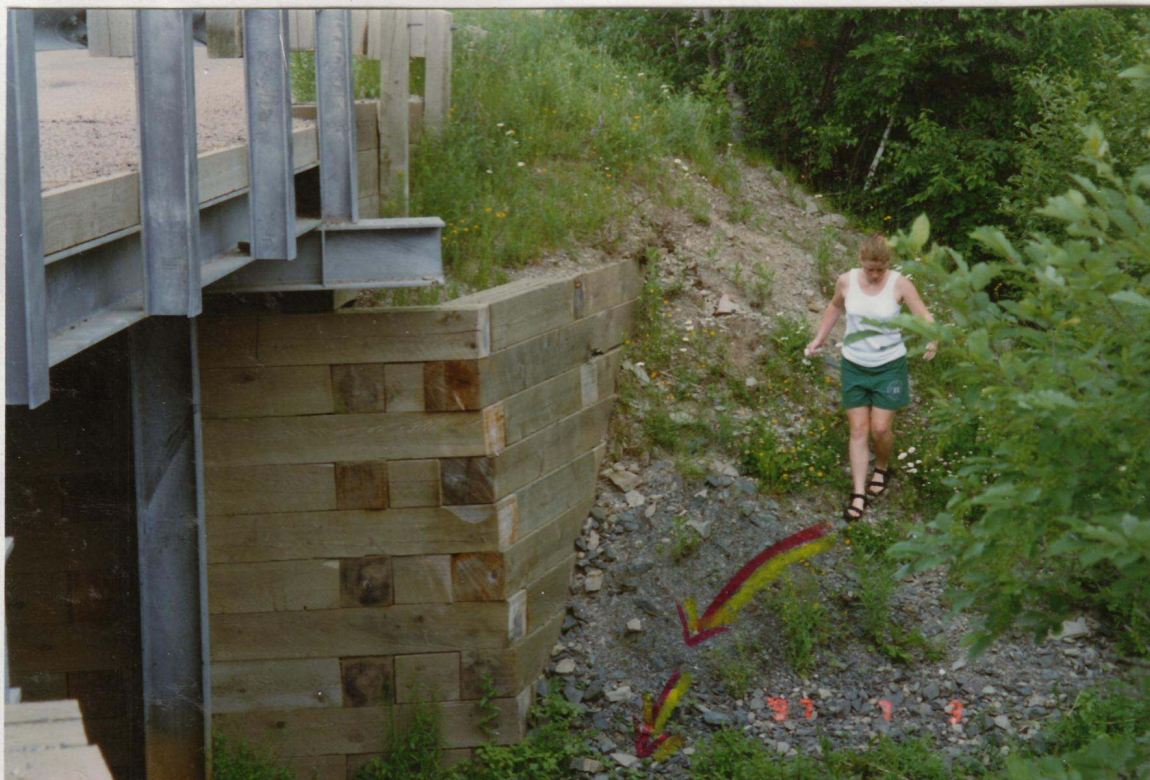
SITE #5

Site #5- Sample is taken at South branch of the Napan River, southern most bridge on the Hannah Hills Road in Upper Napan. The sample is taken on the downstream side of the bridge. The Hannah Hills Road is about 2 km up from the highway (first road to the right after turning off of the highway).

"SOUTH HANNAH HILLS BRIDGE"

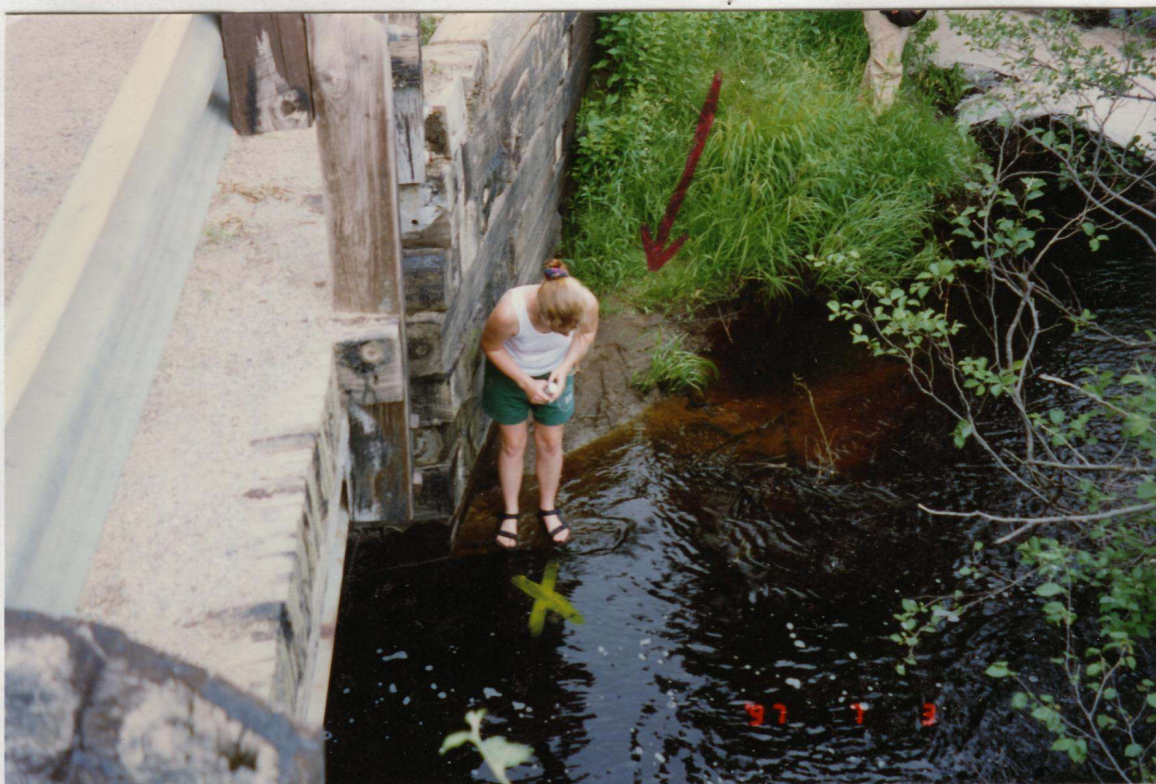
SITE #6

Site #6- Sample is taken from the North branch of the Napan River and is taken from first bridge North of Site #5. (The two bridges are <100m apart). The sample is taken down river from bridge and on the northern side of the river by standing on wood cribbing jutting out from side of bridge.

"NORTH HANNAH HILLS BRIDGE"

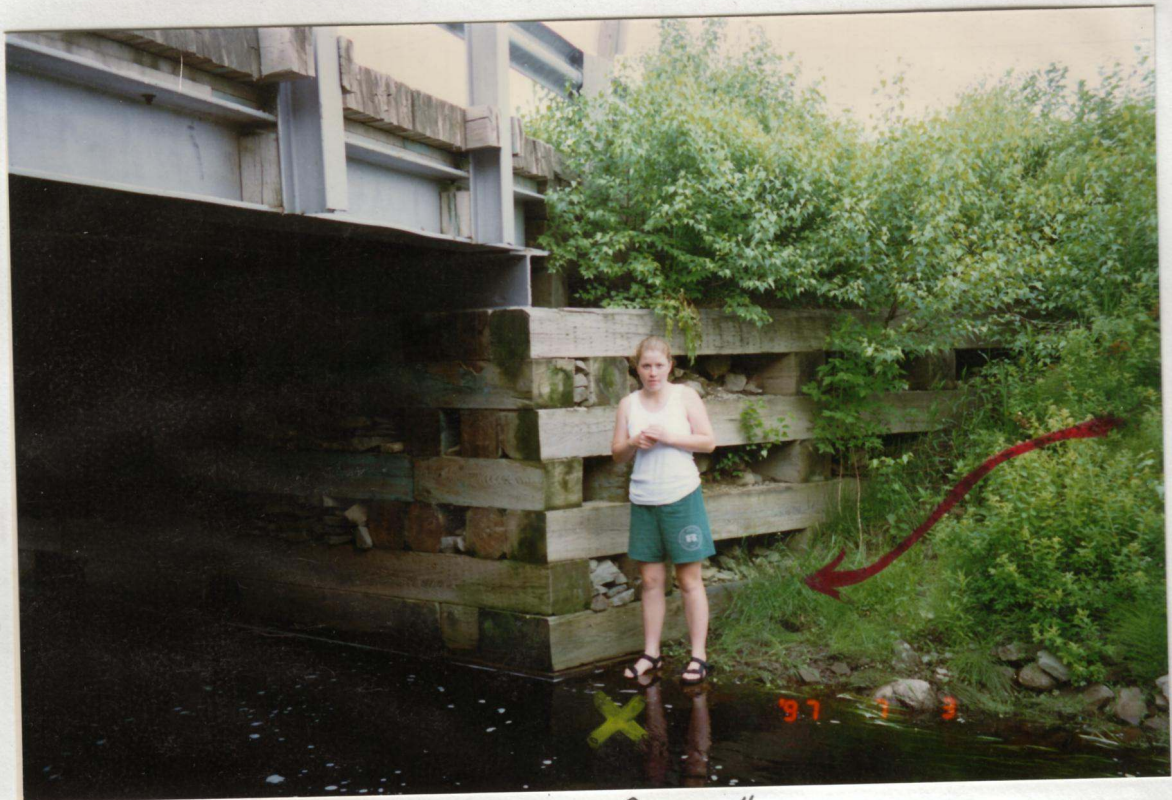
SITE #7

Site #7- Sample is taken from the bridge on the O’Hearn Road about 2 km farther up from the Hannah Hills Road. Sample from the down river side of the bridge on the west side of the river, (i.e. the same side that the house is on). Sample is taken from bridge cribbing and requires reaching down to correct sampling depth.

"O'HEARN RD BRIDGE"
