# Coal Branch River

Atlantic Salmon Conservation Strategy

2022

Miramichi River Environmental Assessment Committee

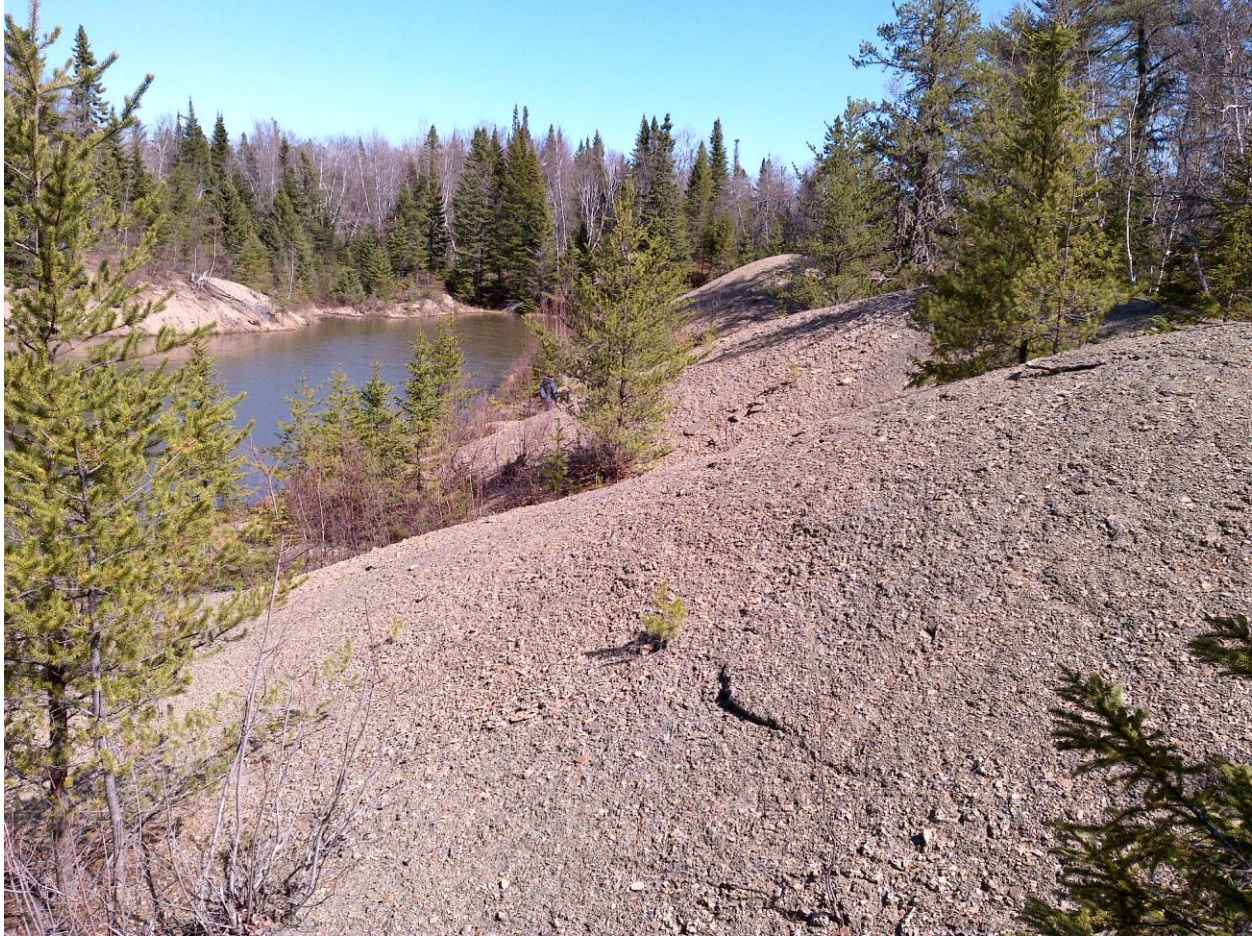
*Figure 7 Tailings Field and Holding Pond from Coal Mining Operations*

The strip-mining sites offer dramatic testimony to their impact on the landscape (Figure 6). Figure 6 and Figure 7 illustrate this mining history. The land has never been remediated and

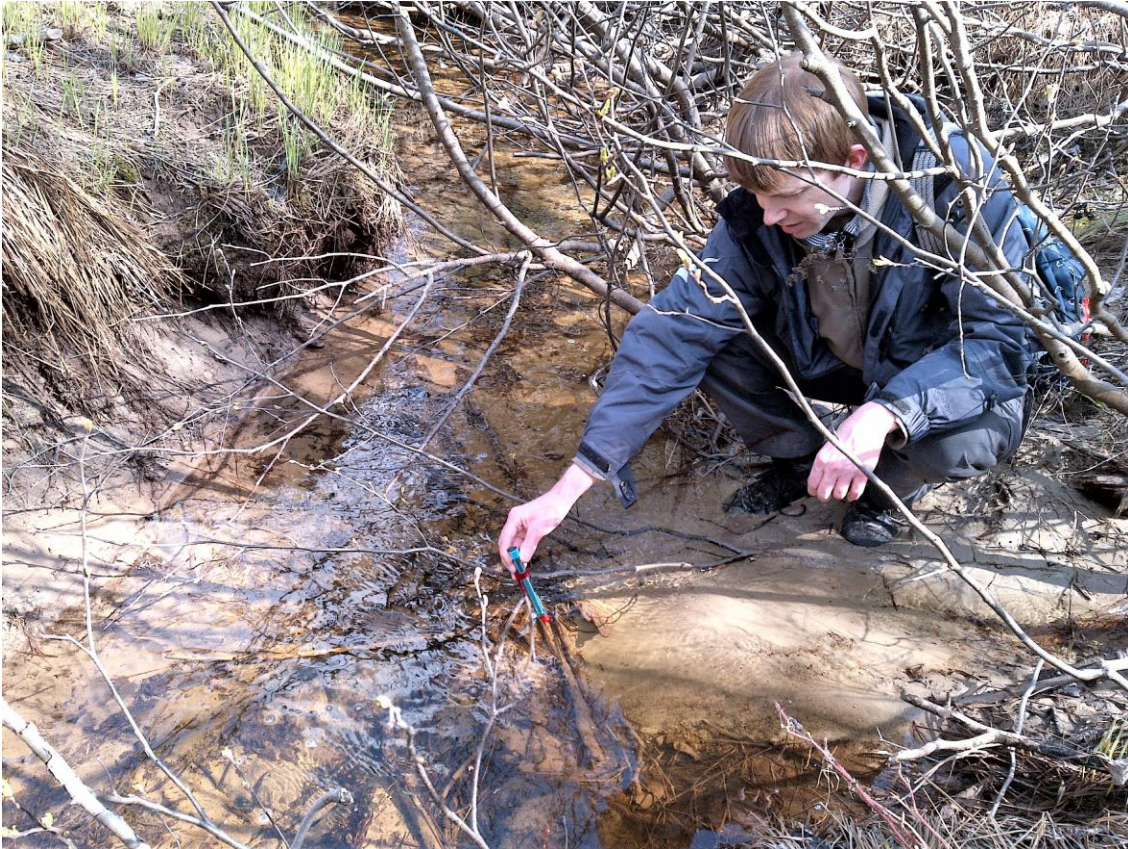
*Figure 8 pH Monitoring at Discharge from Former Coal Mining Site*

- Results of pH monitoring of the Coal Branch and multiple feeder streams to the main branch do not suggest that this history is limiting salmon production. (See Appendix D.)
- A wide suite of general chemistry parameters did not flag any specific industry related compounds that would limit habitat conditions for Atlantic salmon. (See Appendix E.)

***Recommendation:*** *Monitoring of the Coal Branch River for pH levels should continue annually in late-winter and spring.*

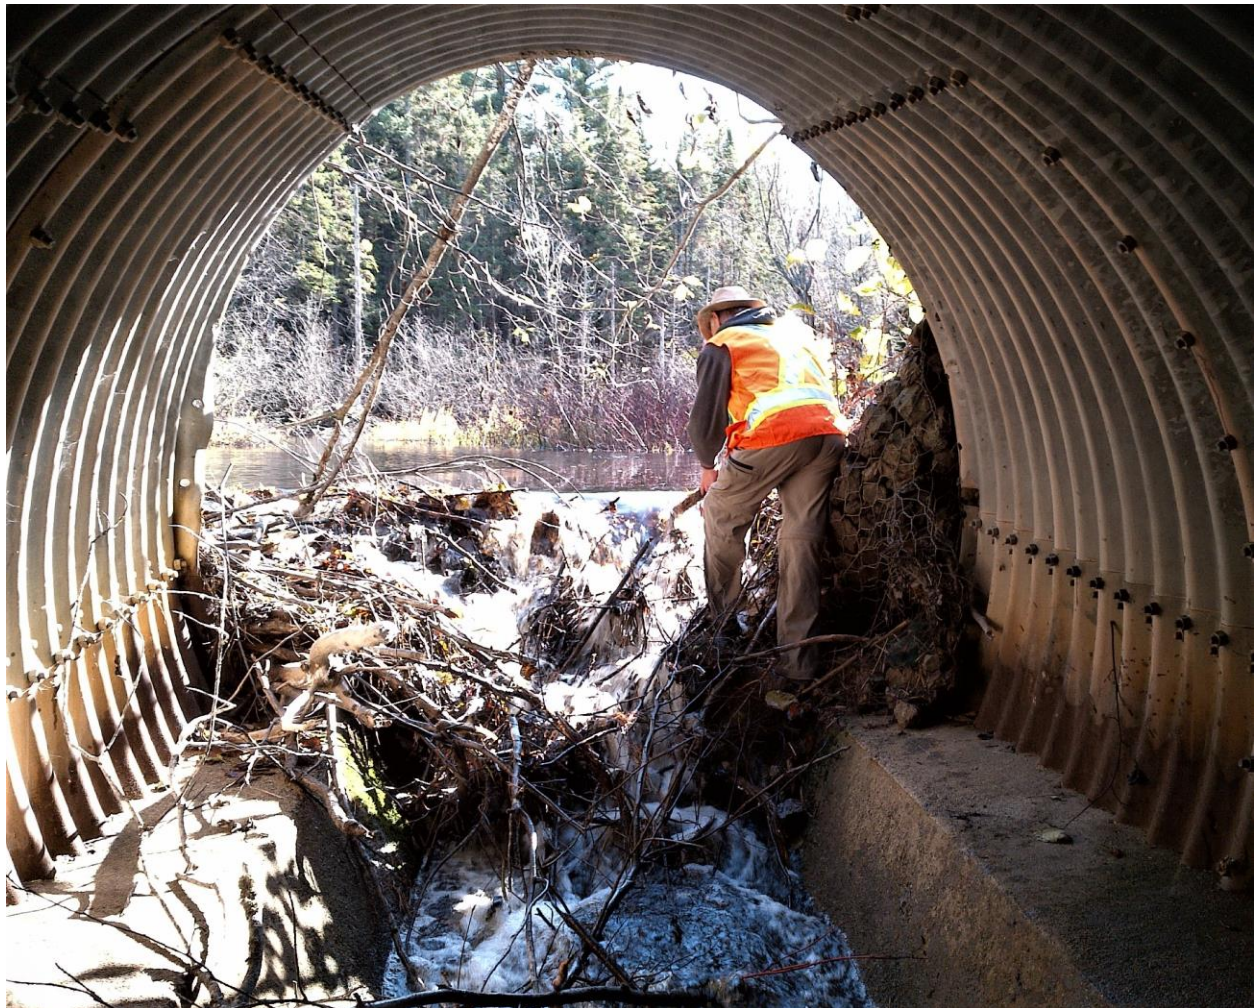
*Figure 11 Notching a Beaver Dam to Allow Fish Passage*

From field work and specific river travels, beaver dams are a common feature in the headwaters of the Coal Branch. This is also true of the smaller tributary streams. Road access to many of these waterways is limited and beaver activity is likely to be more of a factor than realized. Three dams that blocked culverts (Blind Brook and Big Brook ) were notched. Dams on Snake Brook and the South Forks were also notched to allow temporary access to migrating or spawning fishes. No fish were observed moving above these barriers at the time.

***Recommendation:*** An annual program of notching beaver dams in the late fall during spawning season should be implemented to extend spawning further into the Coal Branch headwaters.

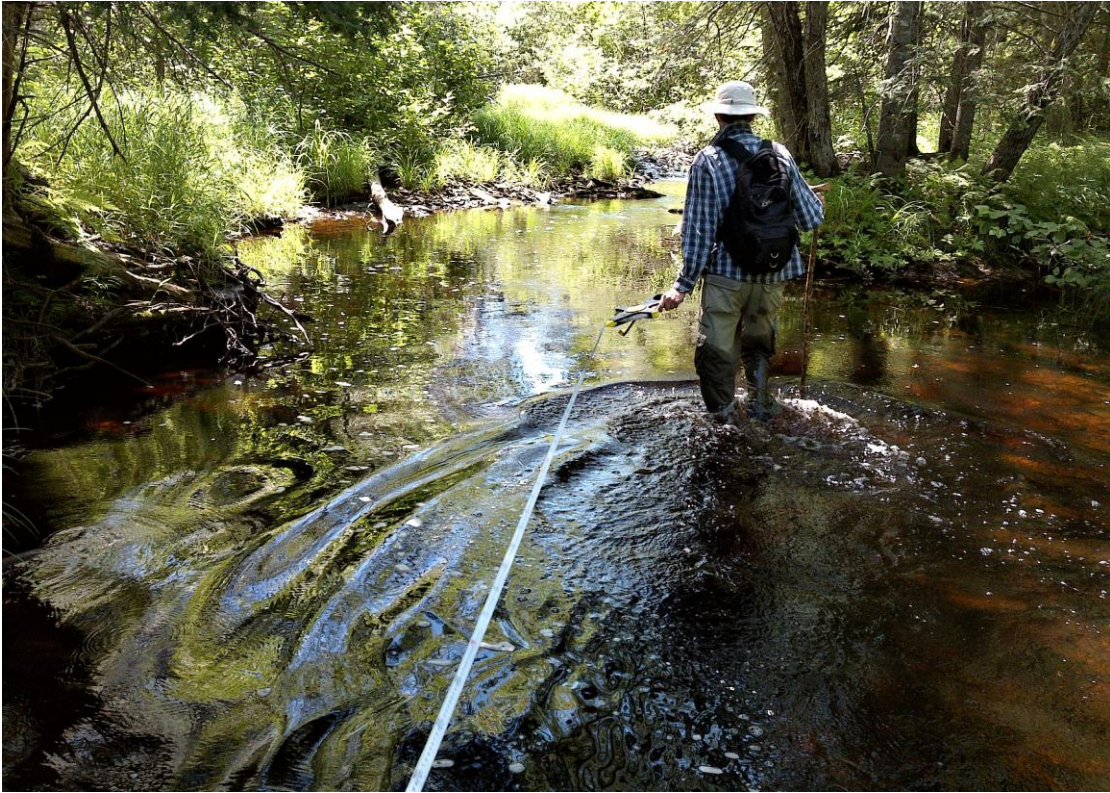
*Figure 12 Habitat Assessment on North Fork Coal Branch River*

Two detailed stream habitat surveys were completed in 2022 on one kilometer reaches on the main branch of the Coal Branch River and on the North Fork Coal Branch River respectively. (Appendix C). These reaches are presented as representative sections of these waterways. The results of the habitat assessments showed general physical conditions conducive to rearing Atlantic salmon. The DNR&E / DFO – New Brunswick Stream Habitat Inventory field forms indicate that the overall physical characteristics show favorable conditions in the number and depth of pools, available shade, potential cover with woody debris, bank stability, and vegetation along banks. The substrate would allow for nesting activity (i.e. creating salmon redds).

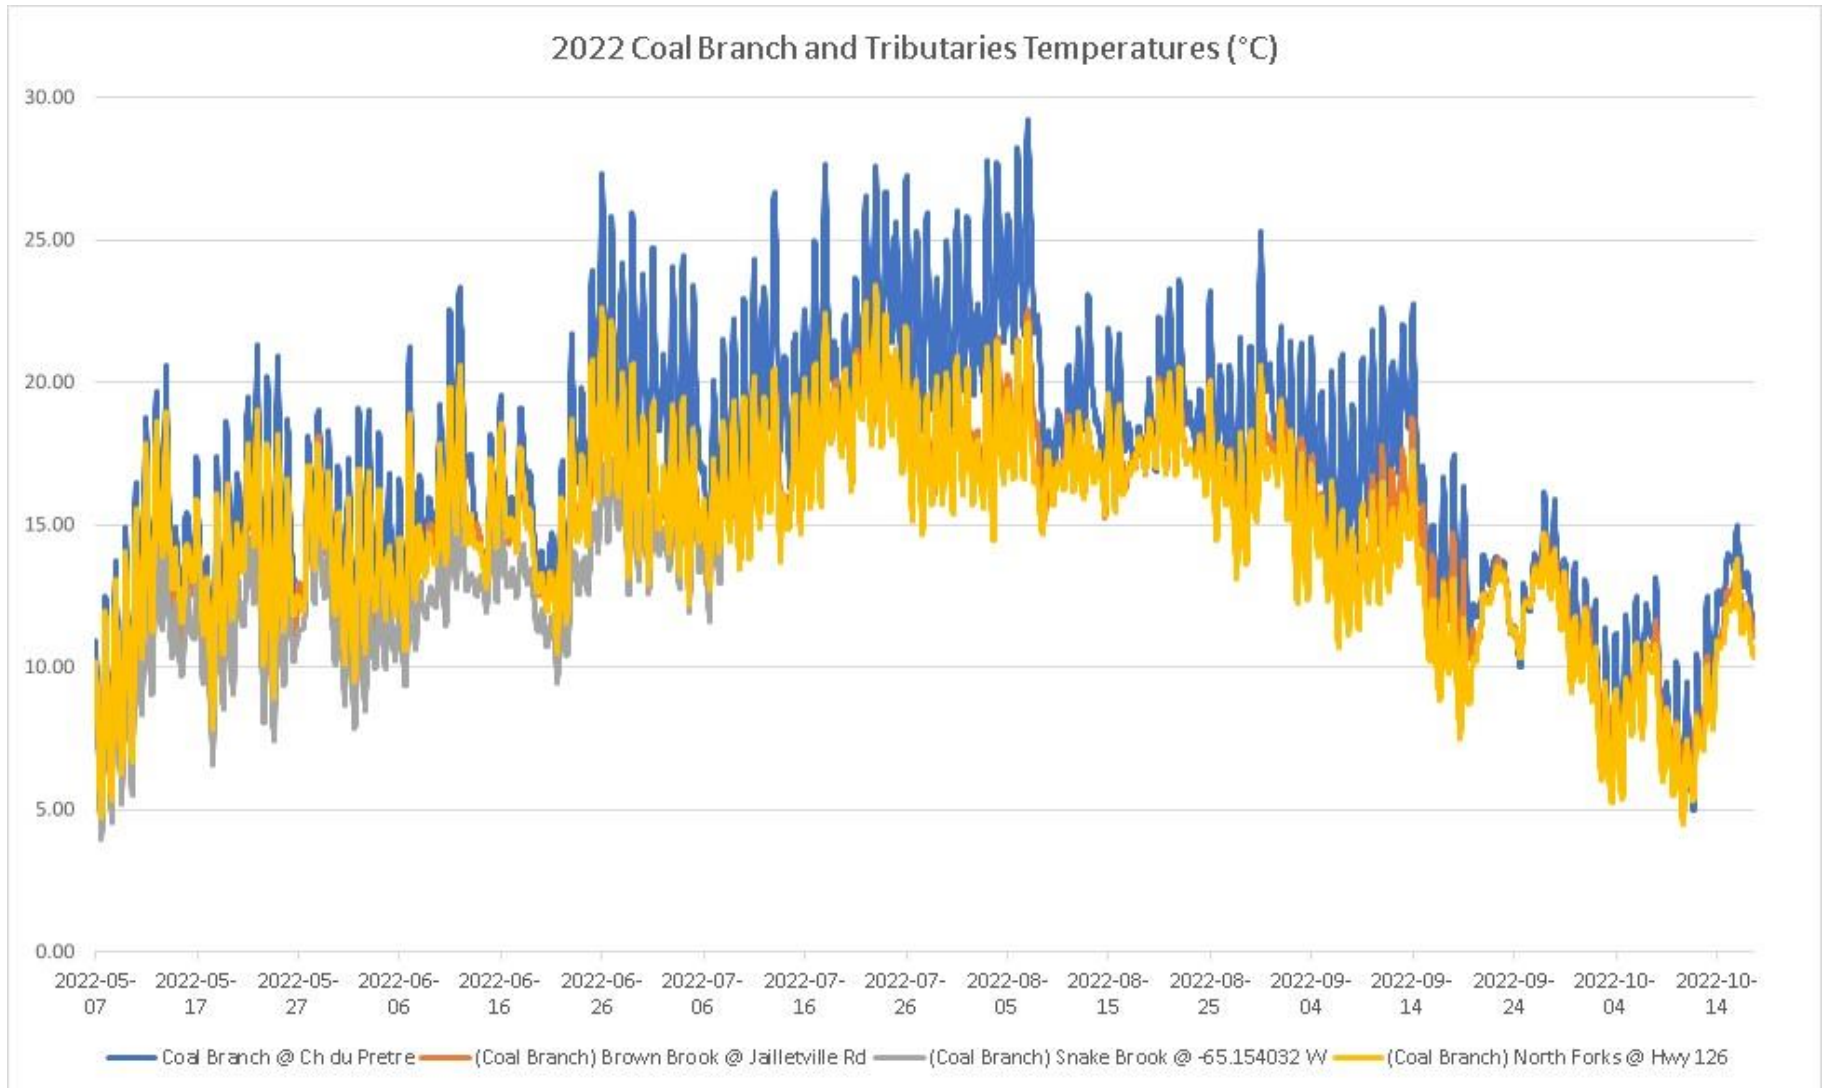
Figure 13 Water Temperature Profiles of Four Coal Branch Waterways

Water temperature loggers were placed at seven Coal Branch watershed sites, distributed on various branches and tributaries, with one on the main branch. Only four of these were successful recovered. Beavers had removed at least two of the original seven loggers, but one of those was recovered, found embedded in the adjacent dam. The embedded logger provided a water temperature data set up to the point when the beaver, on July 9<sup>th</sup>, included it in the dam above water level. Figure 13 represents a water temperatures composite from the four Coal Branch River sites from 2022 monitoring. Appendix B provides the temperature profiles for each of the recovered loggers.

Of the four sites of the recovered loggers, only the main branch at Du Prêtre Rd exceeded the 23°C salmonid thermal stress level for a significant period. Much of the riparian zone here has been cleared and thus offers little shade. This is illustrated by the significant difference in temperature profiles from the other three logger locations (Figure 13) It also represents the most downstream and widest of the monitoring locations. Snake Brook was the coolest of the successfully monitored waterways in 2022.

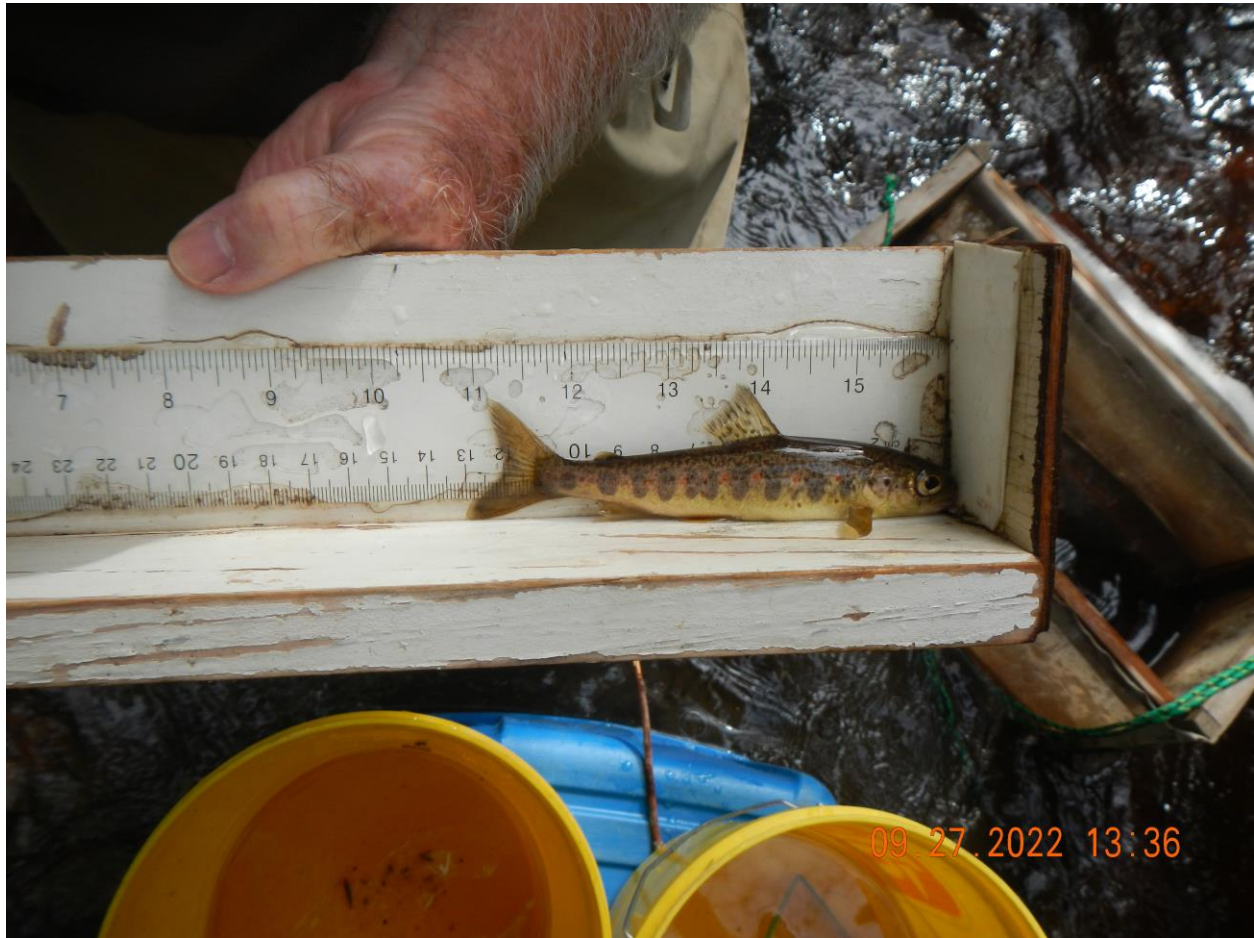
*Figure 14 Salmon Parr Captured While Electrofishing on the Coal Branch River*

Two electrofishing sites were fished by Mr. Rod Currie, fish biologist with Hilcon Ltd, Fredericton, on September 20<sup>th</sup> and 27<sup>th</sup> respectively. Mr. Currie was assisted by Julia Horncastle (Hilcon Ltd, Fredericton) and two MREAC staff. These results are presented in Appendix A.

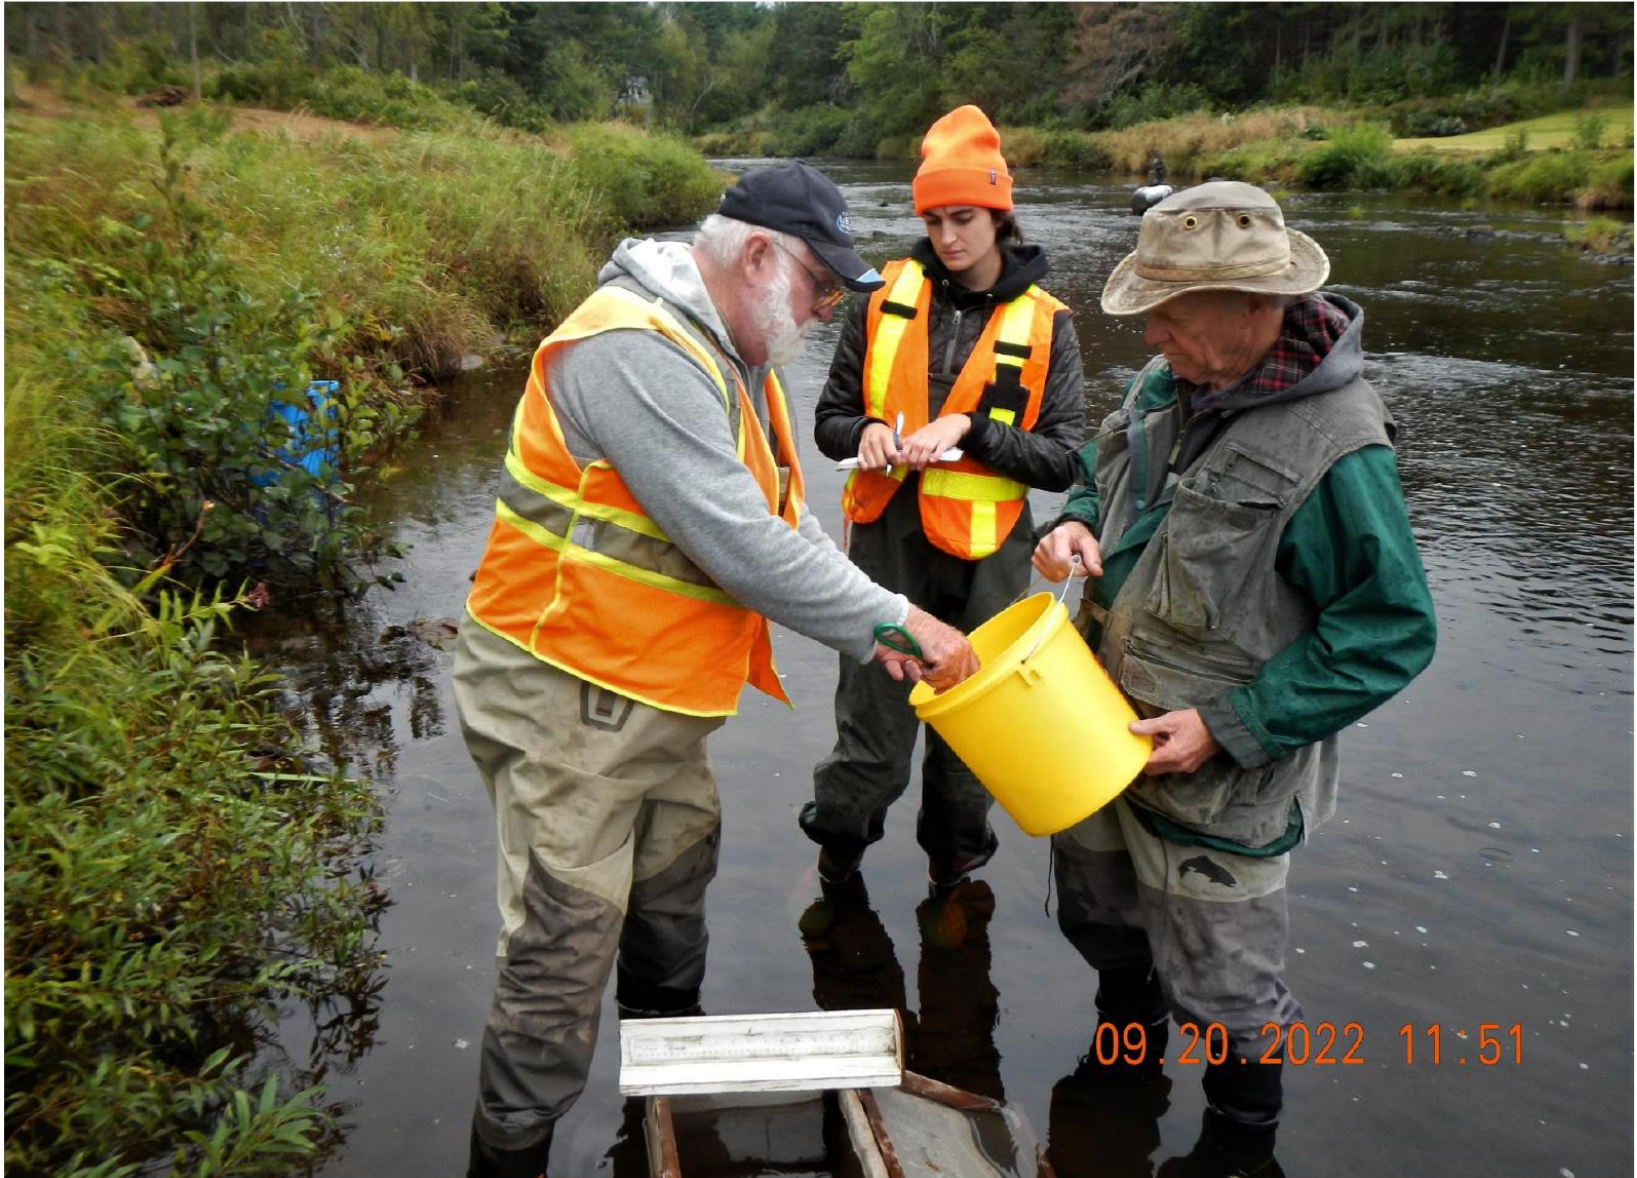
**Figure S1.** Coal Branch River sampling site on September 20, 2022.

Fish population surveys were conducted at two separate watercourses within the Richibucto River watershed: the Coal Branch River, and Blind Brook. These watercourses were surveyed on September 20 and 27, 2022, respectively. The Coal Branch River site was located 50 m upstream of the Chemin du Prêtre bridge crossing near Beersville, Kent County (46.443670, -65.064277), and the Blind Brook site was located 100 m downstream from the Jailletville Road bridge crossing, also near Beersville, Kent County (46.406042, -65.074594). Blind Brook is a tributary of the Coal Branch River. Please see Figure 1 for a map of the locations and Figures S1-S2 in the Supplementary Information for images of the sites.

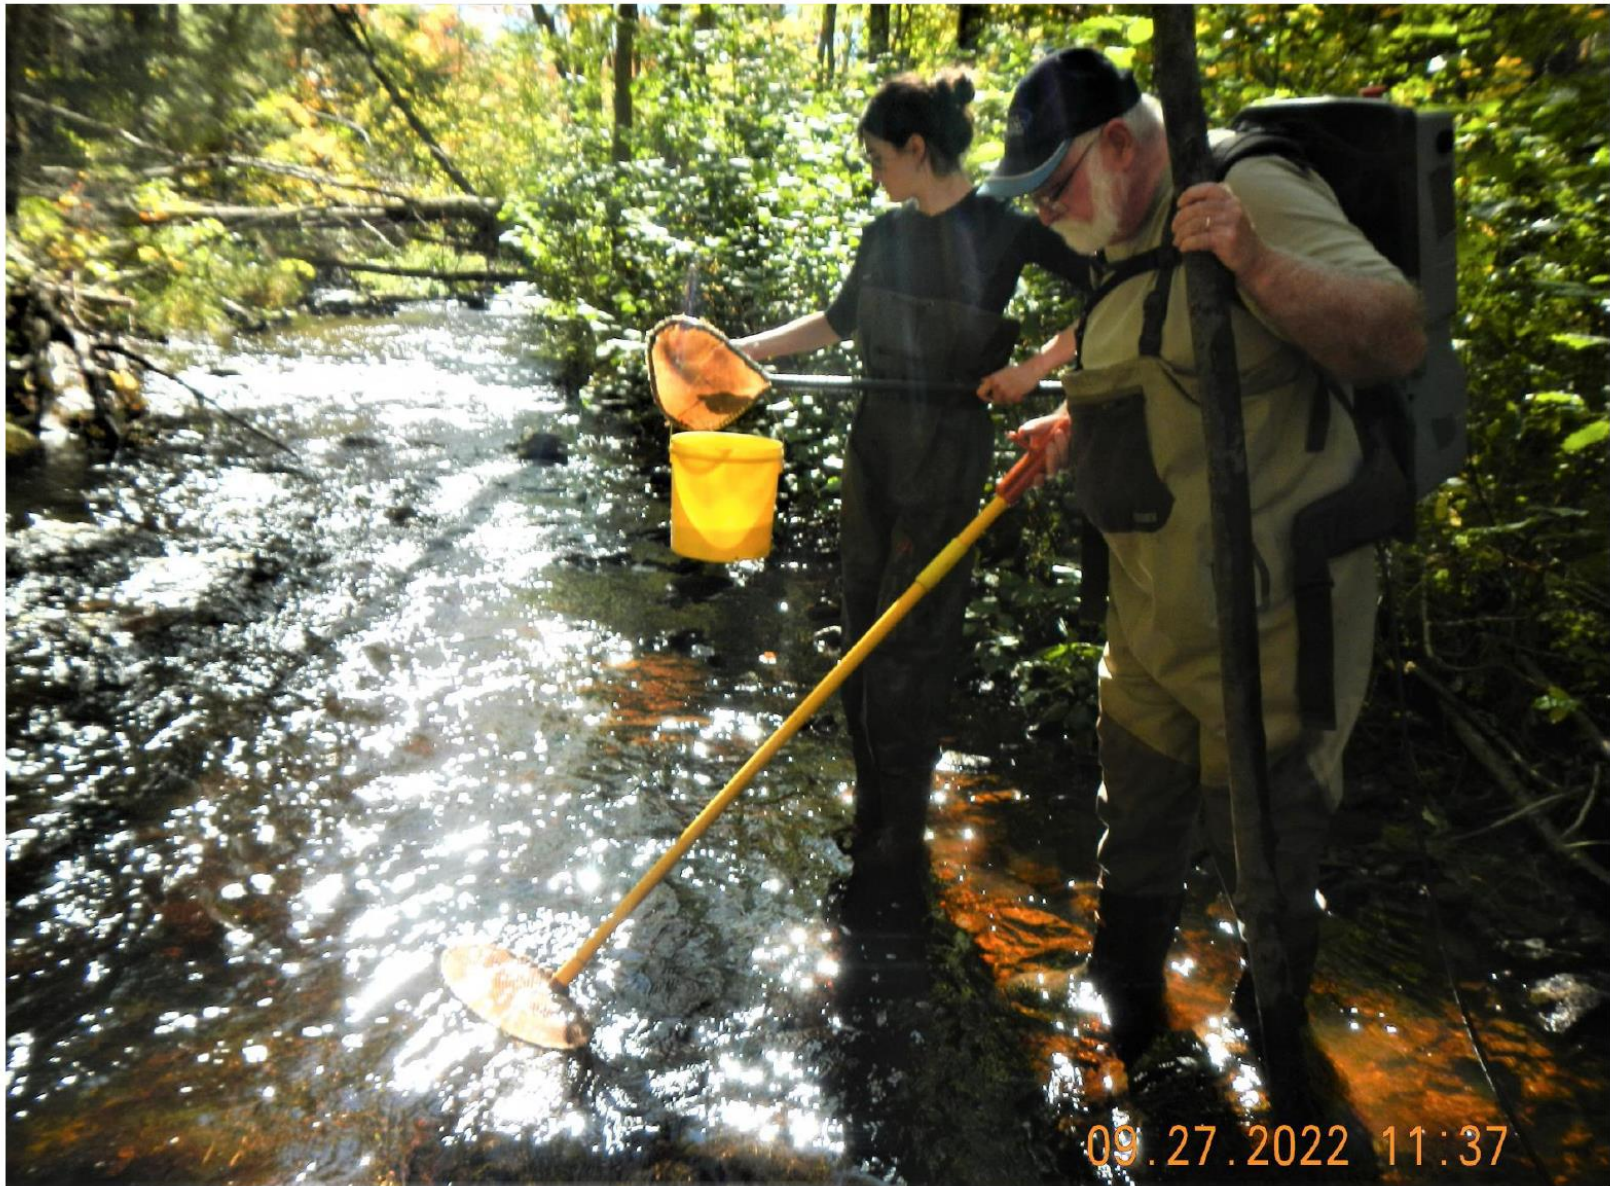
Figure S2. Blind Brook sampling site on September 27, 2022.
